Tehran Cement

Raw Mill – 6

Mill Audit Report

Raw Mill : 6
Date of Inspection : 24.08.10

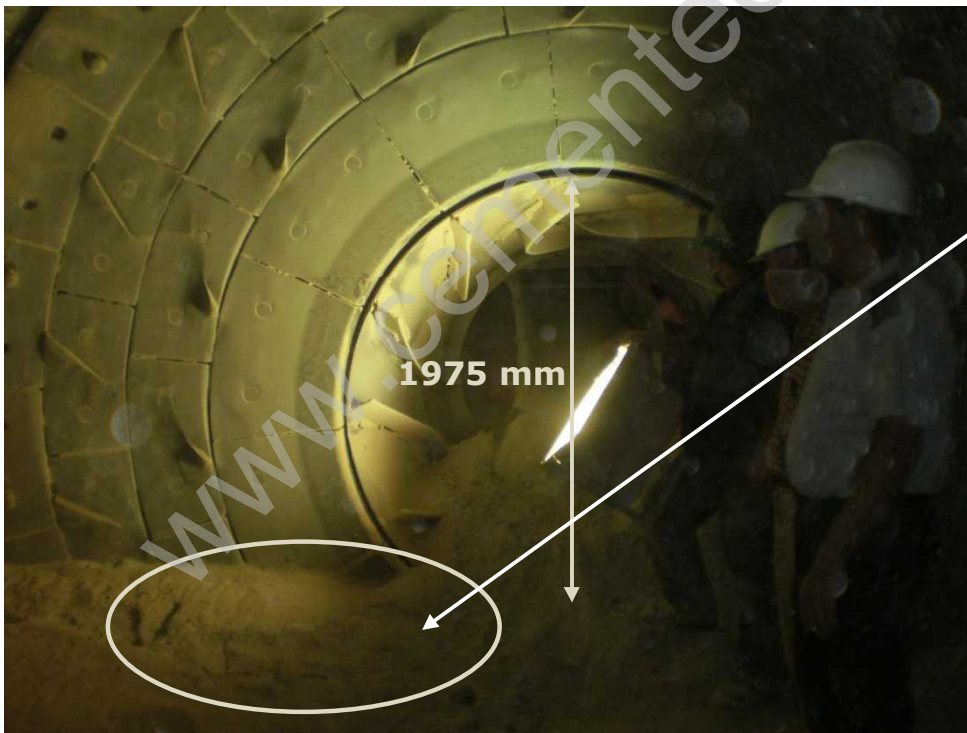
A. Feed Head Liners

Type of liners	: Without lifters
Supplier	: Iran Zob
No. of rows	: Four
Material	: Manganese Steel
Running hours	: Not available, partly replaced on breakage/wear.
Condition of liners	: Normal.
Thickness measured	: 55 to 80 mm

- Accumulation of the fine material at the mill Inlet.

- Material level observed 200 to 250 mm over the ball charge, which is very high.

1. Condition of the Feed head liners to be observed on a regular, replacement of these liners to be planned on opportunity to avoid breakage during operation.
2. Step liner observed worn-out and seems to be effecting on crushing of the particle. Redesigning of the liners is recommended to improve overall performance of the mill.

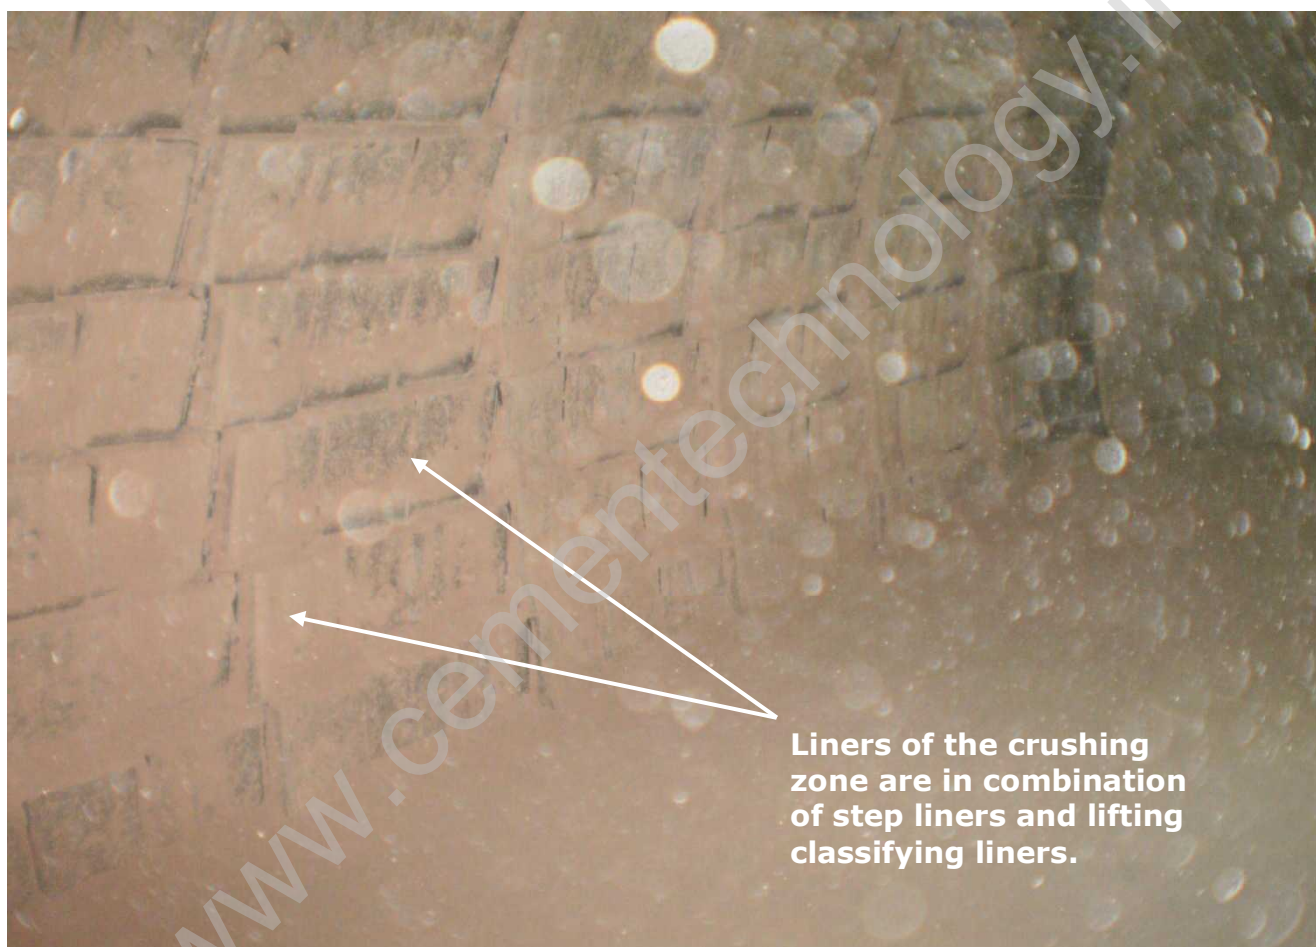
B. Crushing Zone

Type of liners	: Step liners - Bolted
Supplier	: Local - Iranian
Material	: Chrome Steel
Length occupied by the liners	: 4.625 M (37.75% of the mill effect. Length)
Date of installation	: } Part replacement is in practice
Running hours	: }
Condition of liners	: Breakage, wear of the liners
Lift of liners	: 65 to 80 mm.

- Step liners are in worn-out condition and crushing is seen effected due to existing design.
Residue on respective sieves analyzed as R4.75 is 53.57% and R2.36 mm is 55.94%, which is very high.
- Results of the chamber sample analysis indicating poor crushing/grinding through the chamber as well as high accumulation of bigger particles at the mill discharge.
- Redesigning of the chamber with high efficiency crushing liners is recommended to improve mill performance.

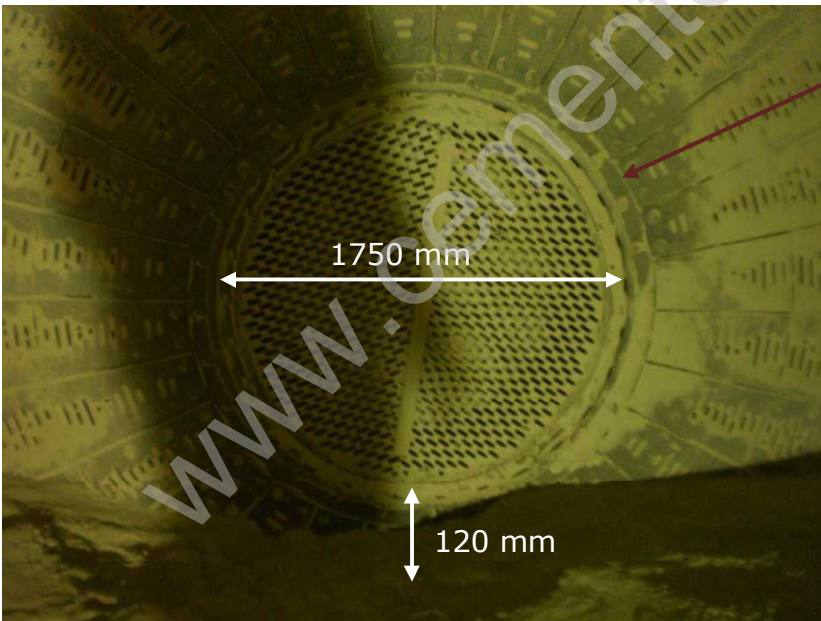
Outlet Diaphragm
- Liners condition is good.
- Slot size measured 10 mm.
- Thickness measured 50 mm

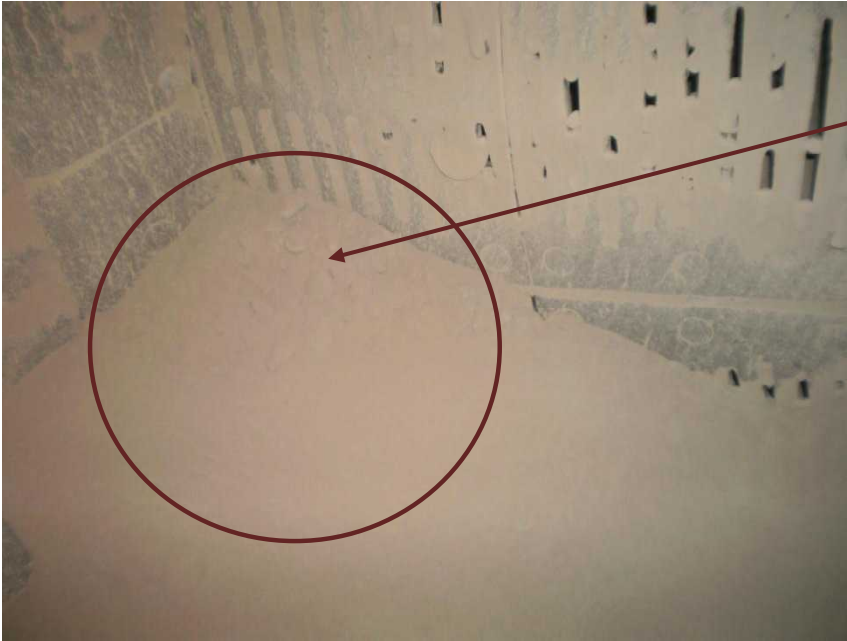
Bigger particles are accumulating at the Discharge end.

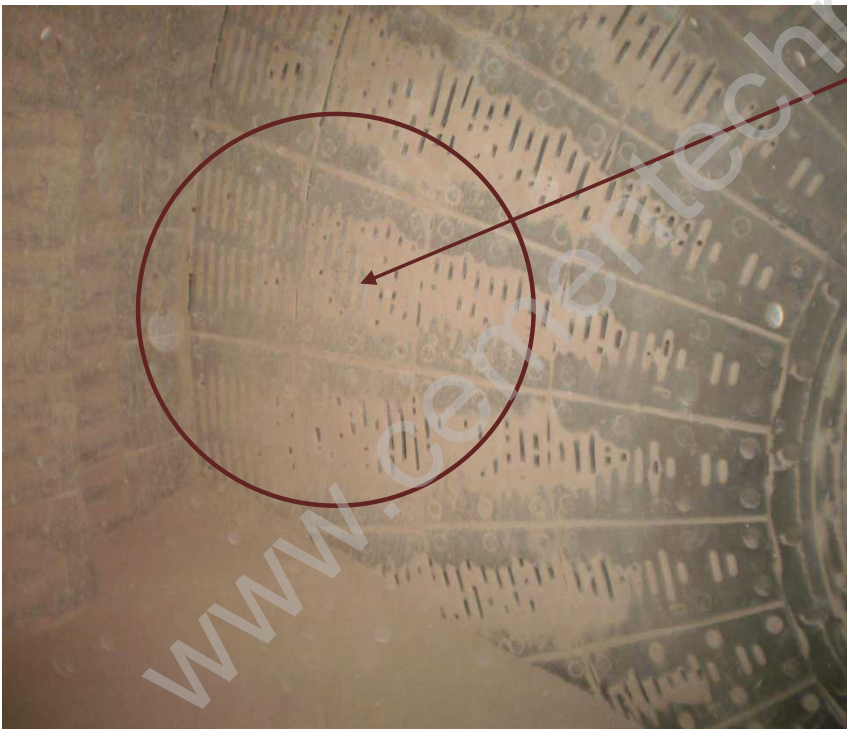
Slots of the Discharge grates observed choked by coarse particle.

- Regular cleaning of slots to be done due to frequent choking of the slots.

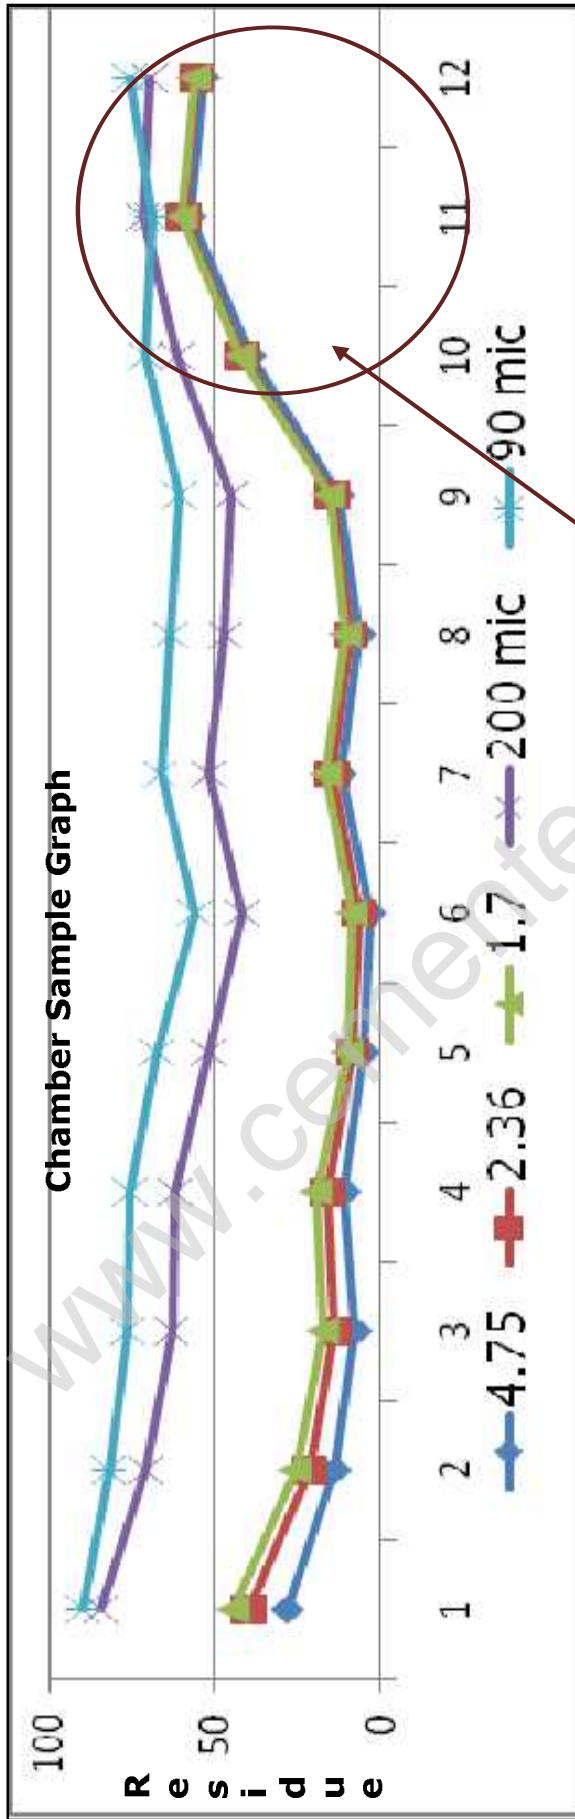
Sieve Size	Sampling Point											
	1	2	3	4	5	6	7	8	9	10	11	12
4.75 mm	28.35	13.93	7.55	10.93	5.01	3.07	12.2	6.15	12.67	39.4	57.69	53.57
2.36 mm	40.01	21.77	13.91	16.15	8.31	6.58	15.05	9.03	14.88	41.91	59.74	55.94
1.7 mm	44.87	26.14	17.6	19.83	10.44	8.96	16.88	10.89	16.04	43.04	60.45	56.7
200 mic	84.56	71.05	63.08	62.16	52	41.73	51.79	46.89	45.26	61.27	71.84	69.43
90 mic	90.08	82.27	76.6	75.95	67.76	56.3	66.75	63.64	61.04	71.06	69.43	75.93

✓ Chamber sample analysis indicating high accumulation near the discharge Diaphragm.
